Title: Surveillance Report on SAVY 4000 and Hagan Nuclear Material Storage Containers Update for Fiscal Year 2019

Surveillance Report on SAVY 4000 and Hagan Nuclear Material Storage Containers Update for Fiscal Year 2019

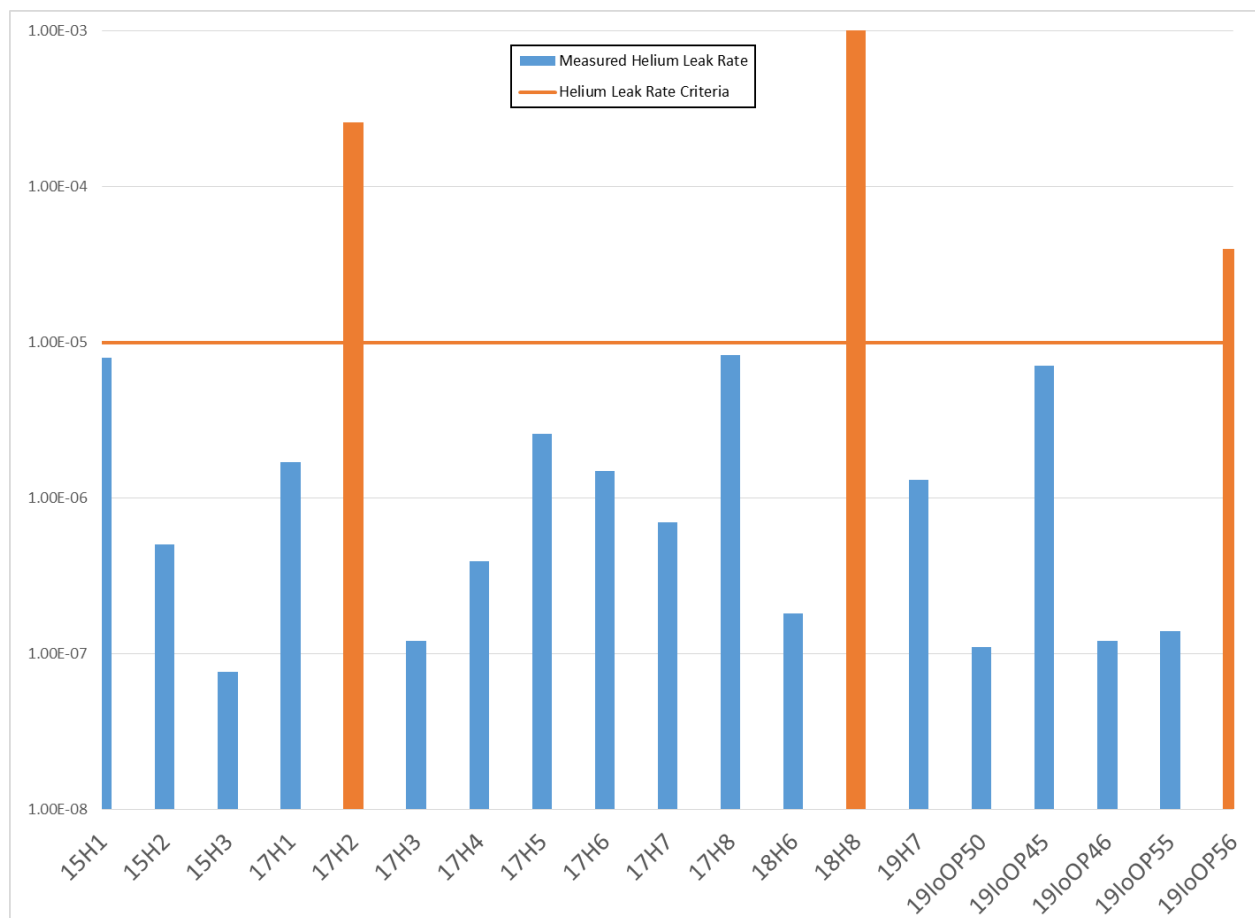
The leakage rate results for the Hagan storage containers are shown in Figure 4-12 for all Hagan containers measured in FY15 through FY19. The measured leakage rates are shown in atm-cc/s of helium at 75 Torr into vacuum. One O-ring failed the leakage test each in FY17, FY18 and FY, with a measurement above the failure criterion of 1×10^{-5} atm cc/s, possibly resulting from the O-ring hardness being out of specification or the amount of compression set. Due to the Hagan's design and lack of historic data on o-ring thicknesses, it is not possible to acquire a compression set measurement. Because the Hagan is designed with a threaded lid that can be closed to different degrees, it makes it difficult to determine what the gland size is for each container.

Figure 4-12. Leakage rates measured for each Hagan container from FY15 to FY19. The red line shows the failure criteria. One container failed each in FY17, FY18 and FY19 (orange bars). Values on y-axis are in atmcc/sec.

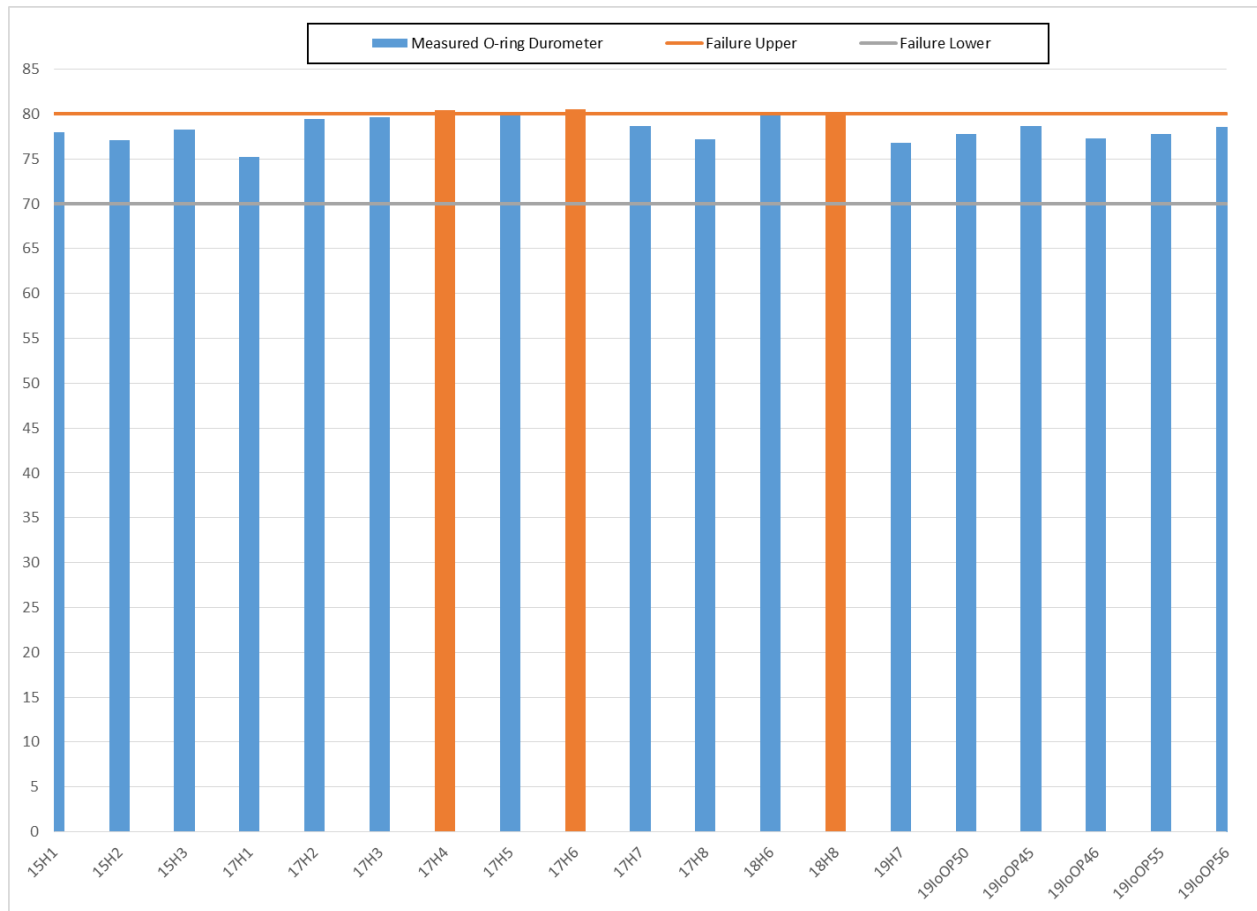
The two Hagan O-rings tested in FY18 had hardness values of 79.9 and 80.1 durometer units, respectively. The O-ring from container 18H8 exceeded the specification limit of 80.0 durometer units. The FY18 hardness measurements are shown in Figure 4-13 as orange bars and compared with the FY16 and FY17 results (blue bars). The O-ring hardness for FY16 through FY18 containers ranged from 75.2 to 81.8 and had an average of 79.2 durometer units. The population of 20 O-rings used as a baseline in the lifetime extension studies have a hardness of 76.8 ± 6.07 durometer units, with a maximum of 78.6 and a minimum of 73.9 durometer units. These baseline O-ring measurements were performed on unused Hagan O-rings that had been stored in plastic bags.

Figure 4-13. Durometer measurements for each Hagan container from FY15 to FY19. The red and silver lines represent the lower and upper bounds for the hardness, respectively. Two o-rings from FY17 and 1 o-ring from FY18 failed the hardness criteria (orange bars) The O-ring durometer values on the y-axis are Shore-M hardness values.

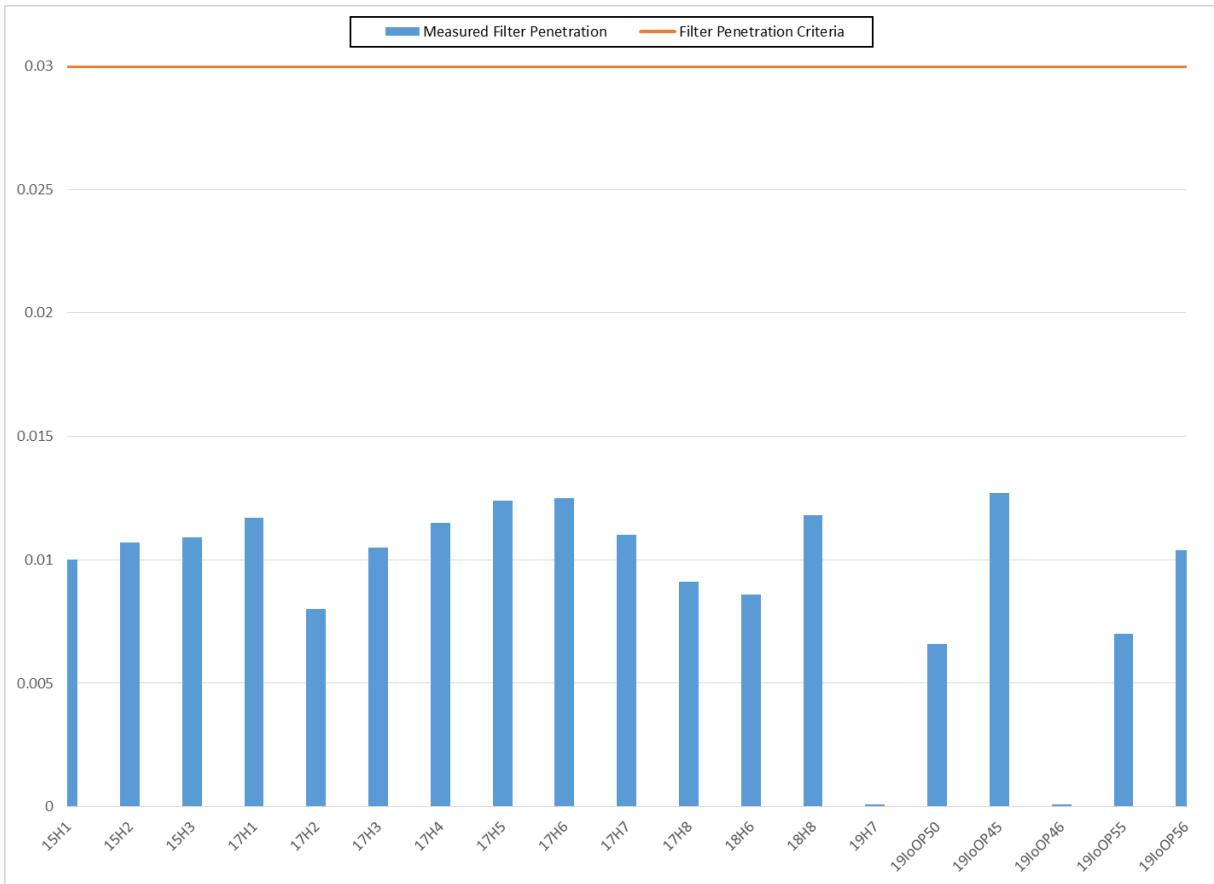
The aerosol data are reported as a percent penetration, also known as the percent leakage. Six Hagan containers were particle penetration tested in FY19 and compared with the results from FY15, FY16, FY17 and FY18 in Figure 4-14. The set of particle penetration measurements obtained in FY15 through FY19 is narrowly distributed and is at least a factor of 2 lower than the requirement. No filters have failed the particle penetration test.

Figure 4-14. Filter particle penetration measurements for each Hagan container measured from FY15 to FY19. The red line represents the upper bound for filter penetration. Values on y-axis are the filter efficiency.

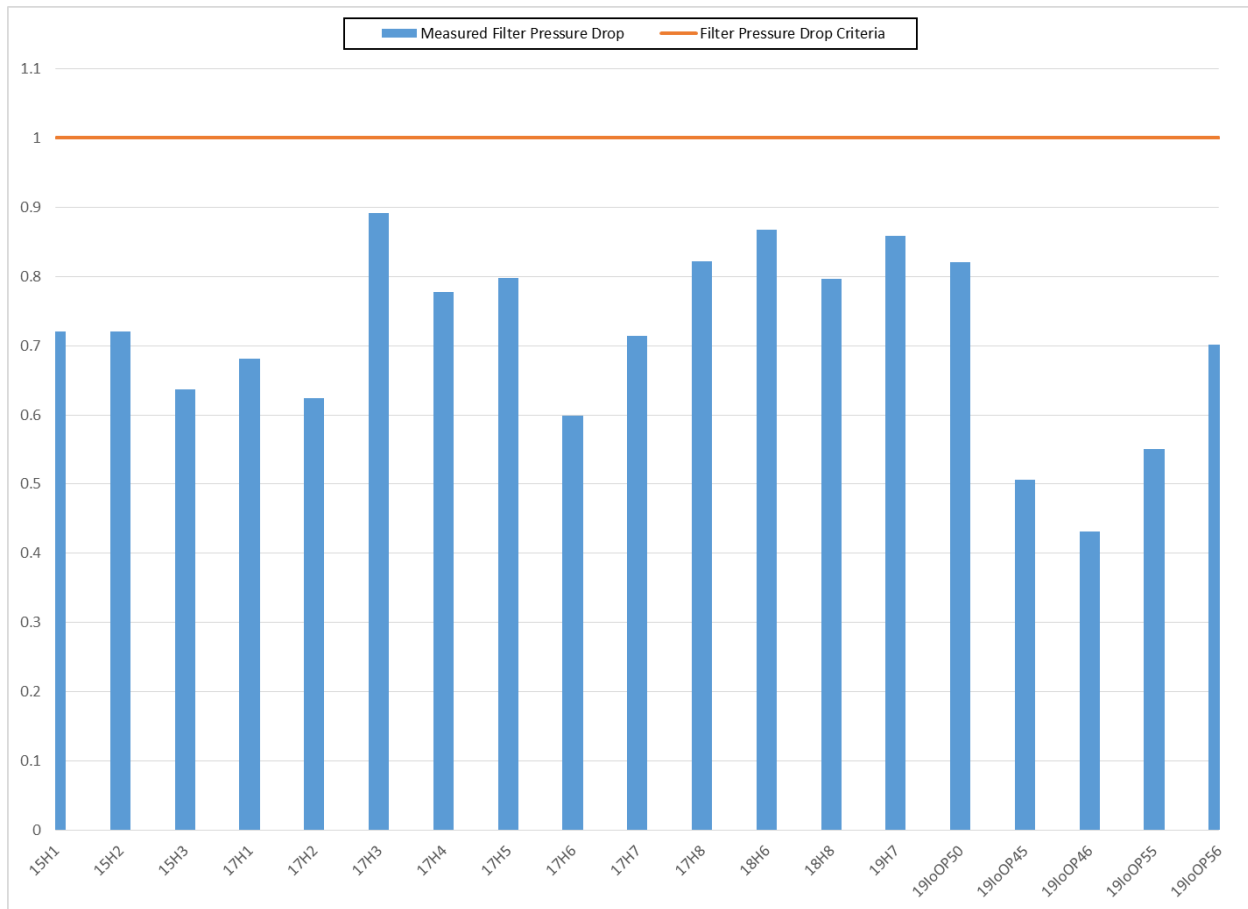
Six Hagan containers were pressure drop tested in FY19 and compared with the results from FY15, FY16, FY17 and FY18 in Figure 4-15. The average for FY15 through FY19 is 0.635 in. W.C.

Figure 4-15. Filter pressure drop measurements for each Hagan container measured from FY15 to FY19. The red line represents the upper bound for filter penetration. Values on y-axis are pressure drop in units of inches W.C.

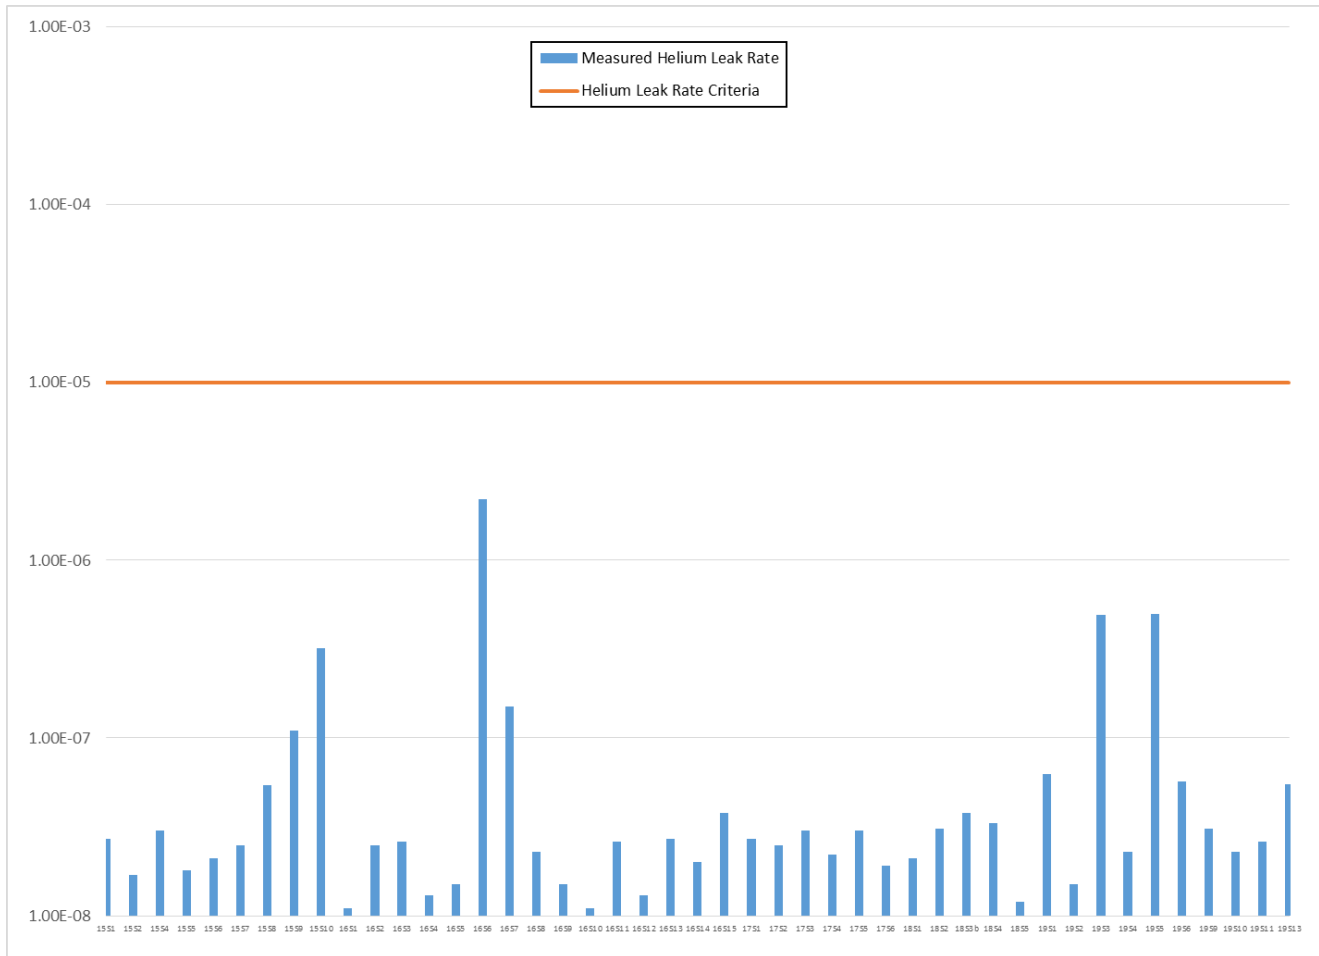
The leakage rate results for storage containers with O-rings installed are shown in Figure 4-29. For storage containers in fy19, the measured leakage rate ranged between 1.5×10^{-8} and 5.0×10^{-9} atm cc/s of helium at 75 Torr into vacuum. Every SAVY 4000 in FY19 passed the leakage test, with all measurements being below the failure criterion of 1×10^{-5} atm cc/s.

Figure 4-29. Leakage rates for surveillance containers, measured for each container are shown as blue bars with the failure criteria shown with the orange line.

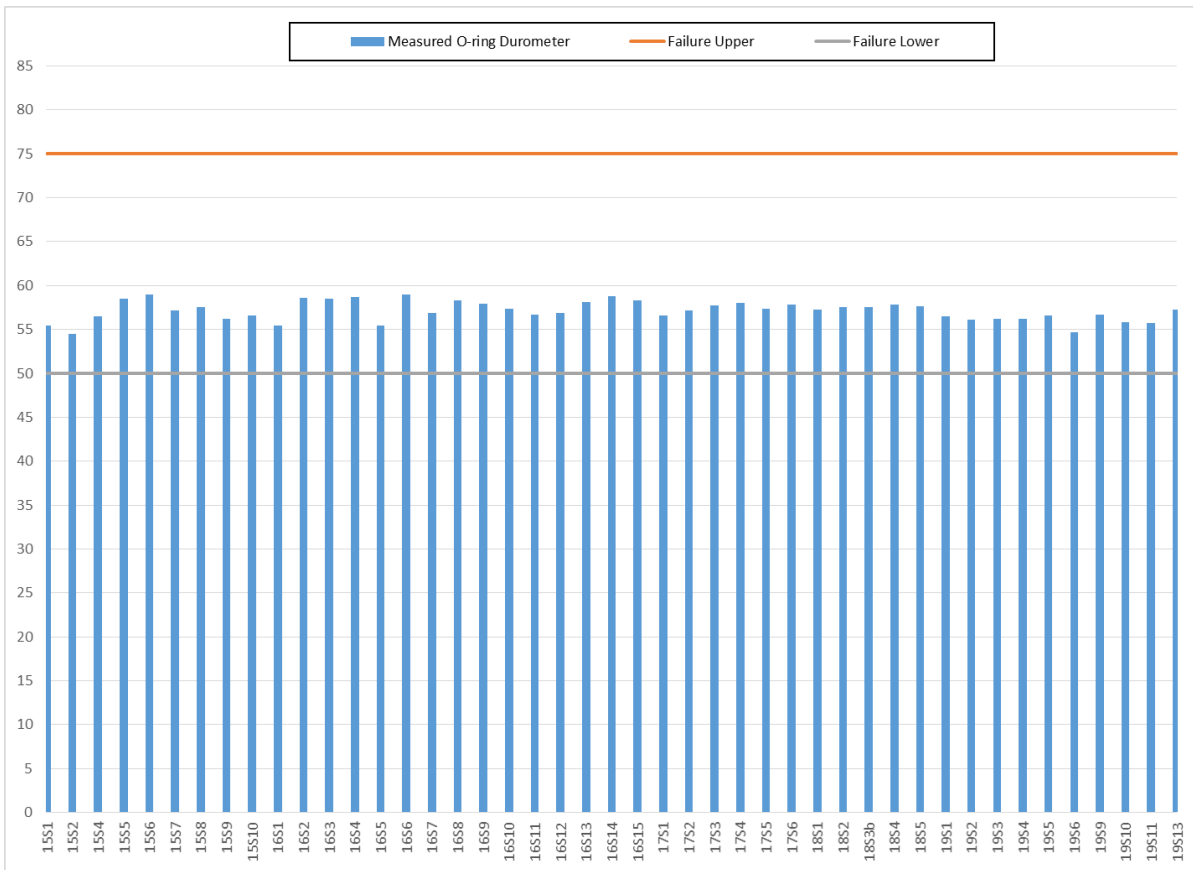
The 10 surveillance O-rings from FY19 were found to have hardness of between 54.7 and 56.9, with an average of 57.5 durometer units. The 21 transfer container O-rings had a hardness between 56.2 and 58.6, with an average of 56.1 durometer units. The 28 O-rings used as a baseline in the lifetime extension studies have a hardness of 57.5 ± 2.62 durometer units, so the storage O-rings are similar in hardness to unused O-rings. The 2.62 unit error is the reproducibility standard deviation as given in ASTM D2240. The measurements are graphed in Figure 4-30. None of the O-rings are especially hard or soft compared with the baseline, and the measurement do not have a significant correlation with age, estimated dose, or item thermal power.

Figure 4-30. Durometer measurements of the surveillance SAVY 4000 O-ring with the red and green and red bands showing the upper and lower failure limits.

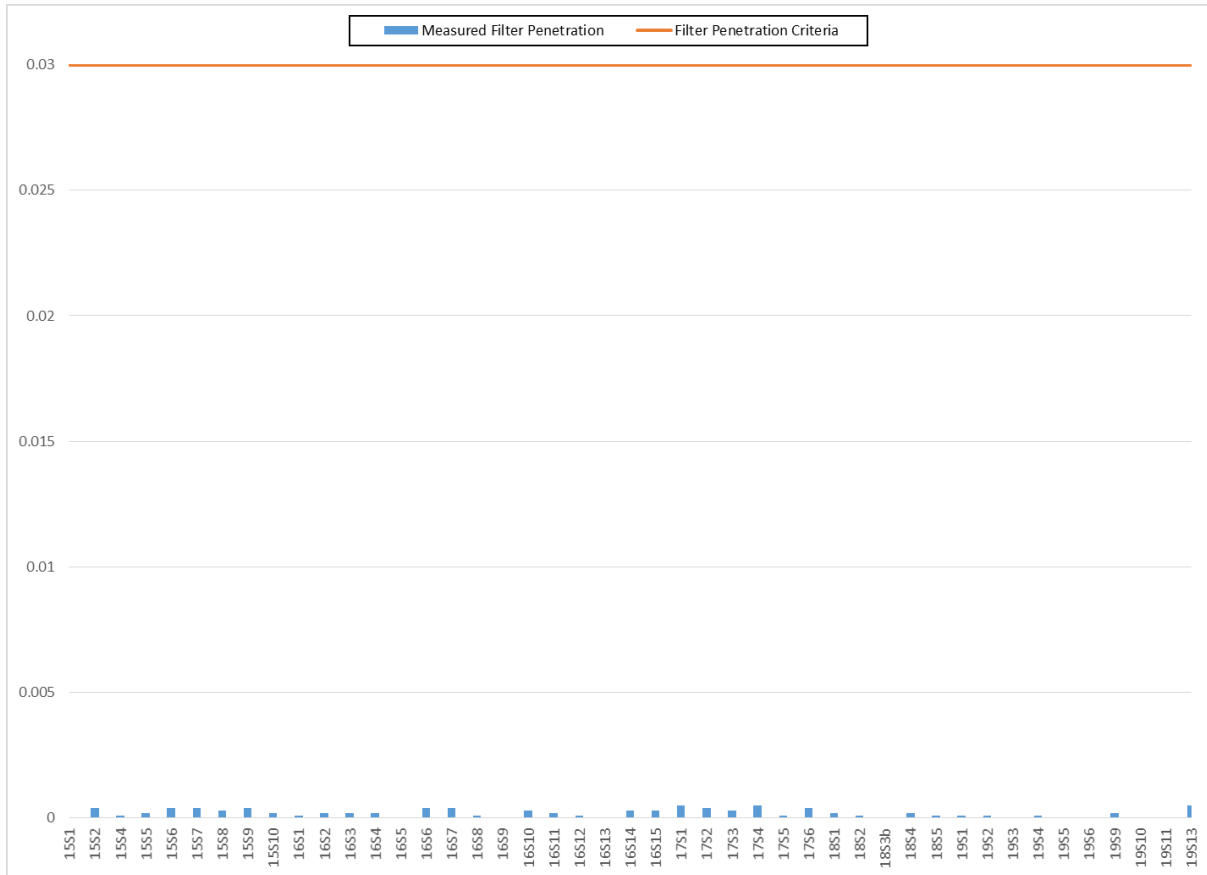
The aerosol data are reported as a percent penetration, also known as the percent leakage. The set of particle penetration measurements is narrowly distributed and very far from the failure criterion as graphed in Figure 4-31 for storage containers and Figure 4-32 for transfer containers. A set of baseline particle penetration measurements does exist, but it

Figure 4-31. Filter particle penetration measurements for storage containers.

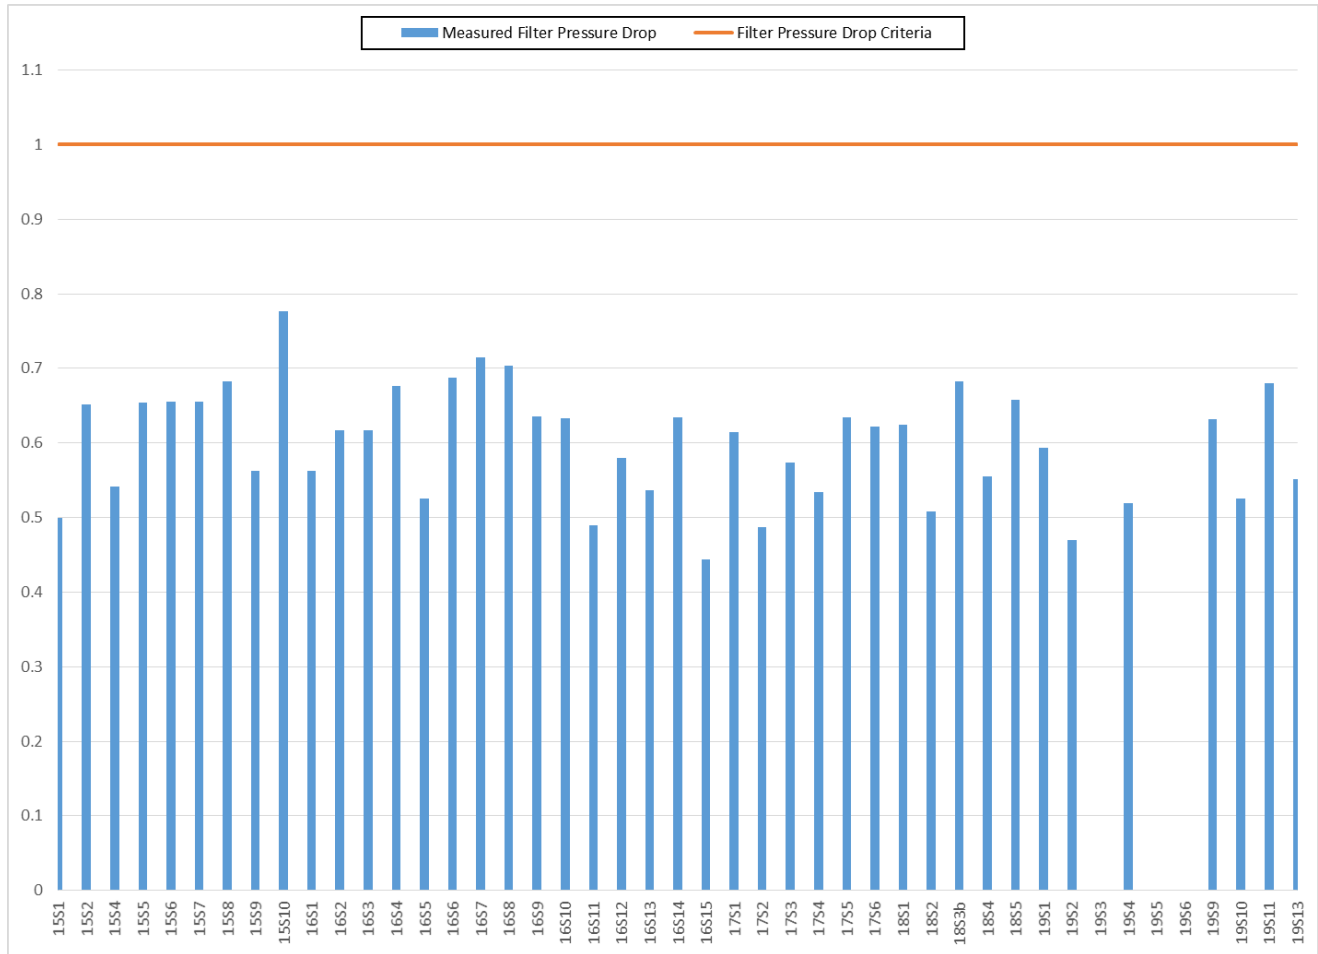
The pressure drop measurements have an average of 0.58 in. W.C. ± 0.07 for FY19 storage. The results are graphed below in Figure 4-32.

Figure 4-32. Filter pressure drop measurements for storage containers.
Where

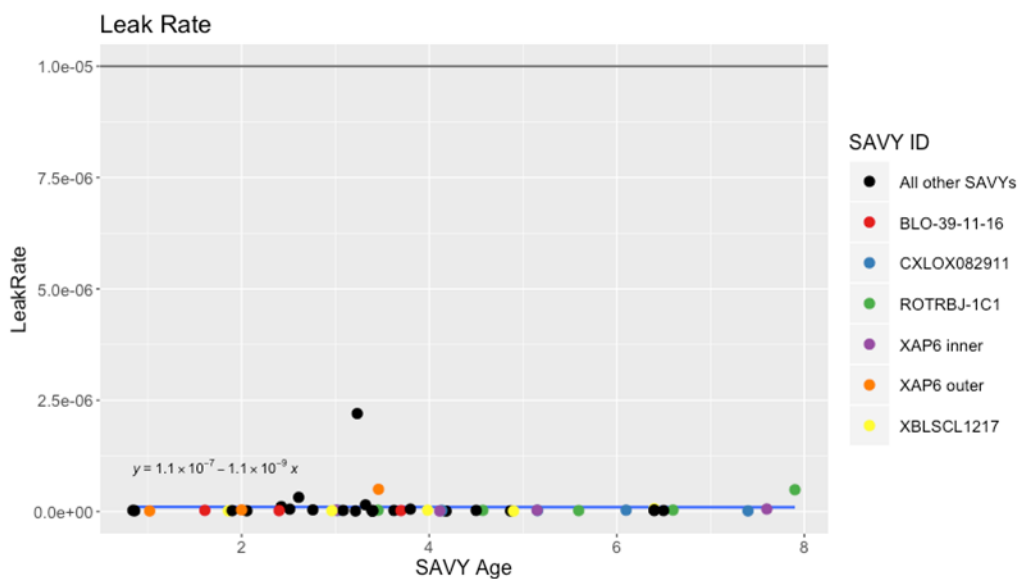
Figure 4-33 shows He leakage rate versus age. The containers denoted with colored circles are the five containers that have been examined at least twice in 2015 through 2019. The black circles are the remainder of the SAVY surveillance containers (16 containers). The black horizontal line is the acceptance limit for He leakage rate. To date, there is no trend with time for leakage rate. This year there was a slight increase in the leakage rate for the XAP6 outer container (orange) and ROTRBJ-1C1 (green). There is one outlier, XBLSCL1213 (the highest black point) that was discovered in 2018. This container was corroded and it required cleaning to pass the leakage test. This container will be re-examined again in a future surveillance. XAP6 outer container and ROTRBJ-1C1 will also be re-examined in future surveillances.

Figure 4-33. Trend analysis of He leakage rate versus SAVY age for containers from 2015-2019.

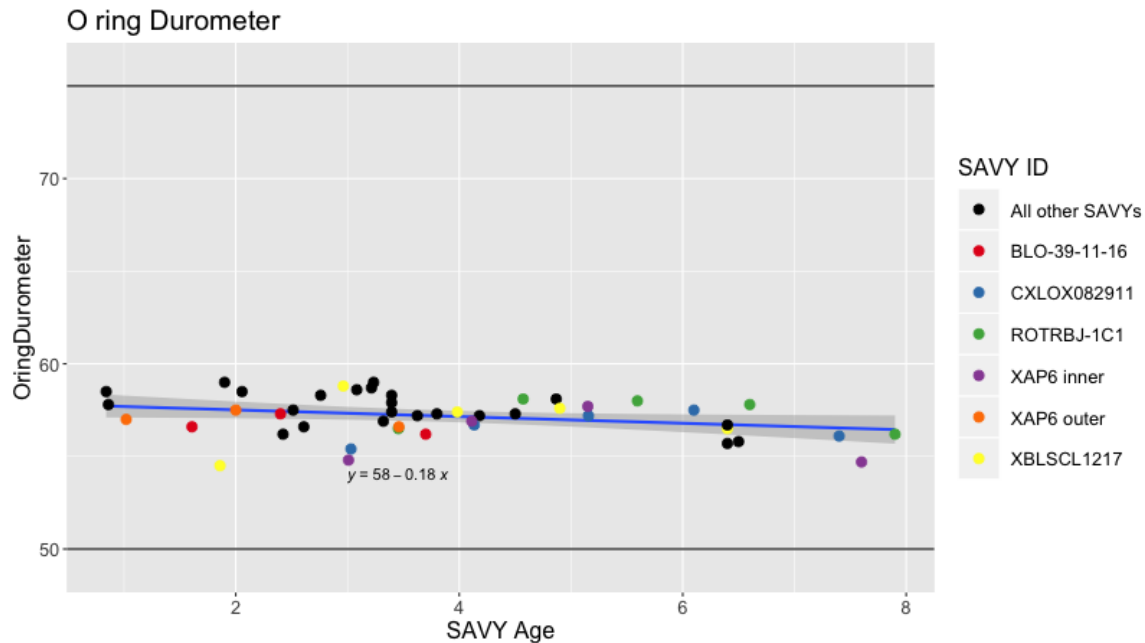
There were no significant O-ring issues found in the SAVY 4000 containers this year. There were small inclusions or scuffmarks seen but the issues did not affect the performance on the O-ring. Figure 4-34 shows durometer measurements versus SAVY age. There is variability in the measurements but no significant trend. The black

Figure 4-34. Durometer measurements versus SAVY age.

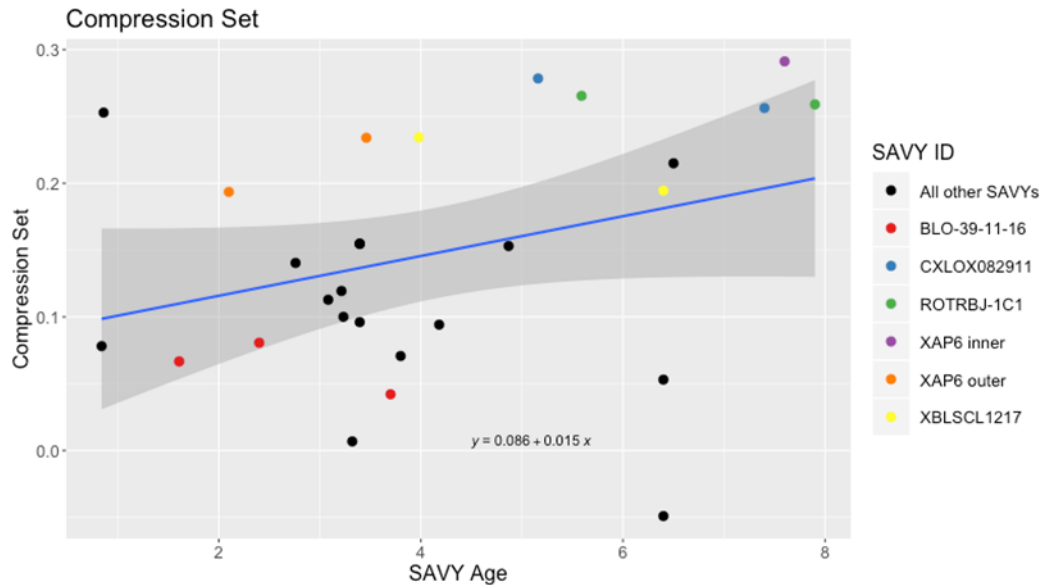
Figure 4-35 shows compression versus age. Details of how the compression data are collected and results for accelerated aging studies are provided in Weiss, et. al. 2016. The surveillance compression data were not collected in 2015 or 2016, there were three measurements in 2017 and in 2018 three measurements were made but two of those were estimated based upon the average gland size for containers. In 2019, there were compression set measurements for all containers ranging from 0.04 to 0.26. There was one container, POX4275C1, that had a negative compression set value (-0.049). This value was excluded in the analysis as the compression set values should be greater than zero. The compression set values are estimated based upon an initial O-ring thickness. The reported thickness may not have been correct for POX4275C1. Additionally, the measurement error reported for the O-ring thickness is 0.0454. The reported measurement for POX4275C1 falls within the margin of error.

Of the six containers with multiple measurements over time (multi-colored dots) only one has more than two measurements, BLO-39-11-16, which has three measurements. The compression set measurements indicate a positive trend. However, looking at the items that have multiple measurements there is not a positive increase except for XAP6 outer (orange dots). All other containers that have measurements over time are approximately the same value or slightly lower. More data are needed before a trend can be reliably assessed.

Figure 4-35. Compression set versus SAVY age.

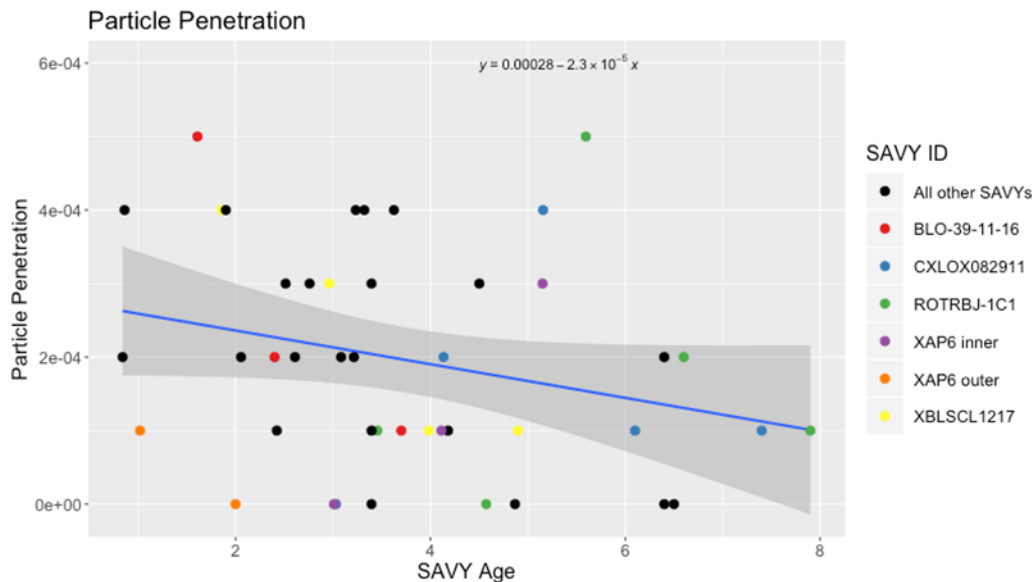
Figure 4-36 shows particle penetration versus SAVY age. This measurement depends on how long the data are collected and the collection time can vary between measurements. The variability in the collection time results in variability between measurements leading to scatter in the actual measurement values across the years. The gray shaded area is the 95% uncertainty band for the trend line. Although the trend appears negative, the variability of the data is such that the trend is not statistically significant. In addition, as shown in Figure 4-37 the measurements are small compared to the acceptance limit, the black horizontal line, and are within the variability of the measurements.

Figure 4-36. Trend analysis of particle penetration versus SAVY age for SAVY containers in surveillance from 2015-2019.

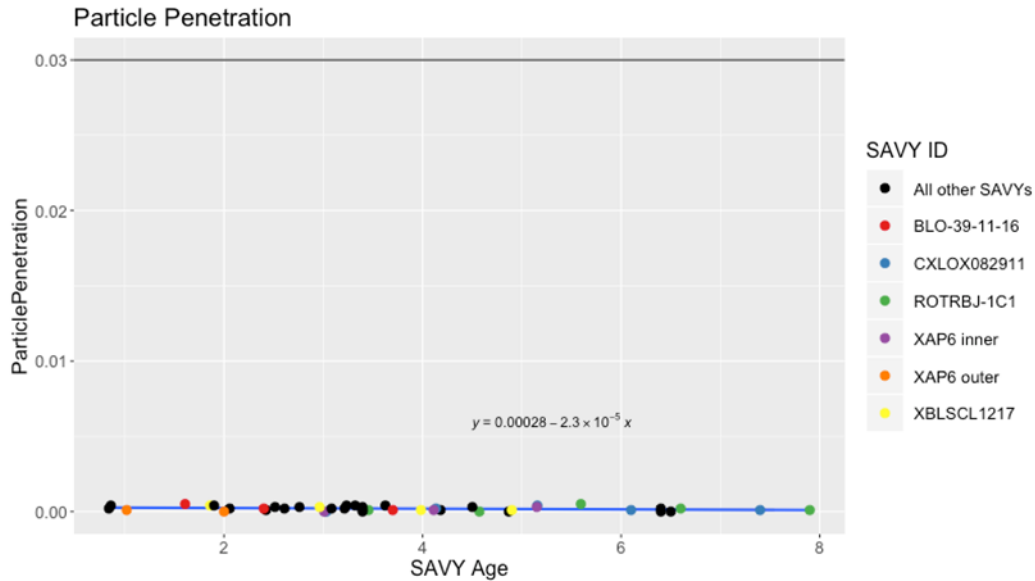
Figure 4-37 Trend analysis of particle penetration versus SAVY age for SAVY containers in surveillance from 2015-2019 shown in context of acceptance limit.

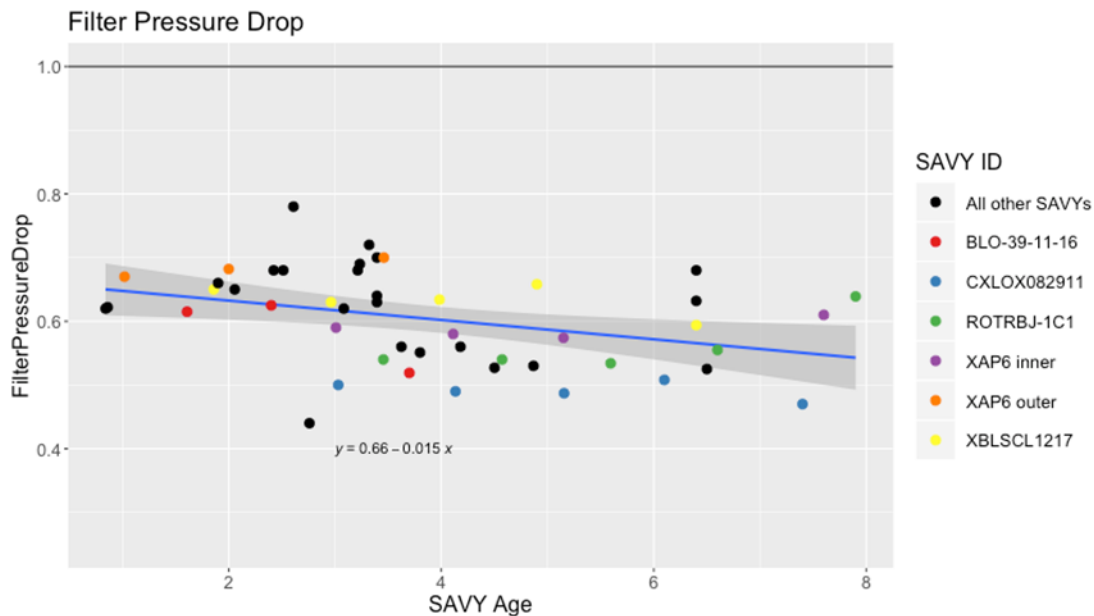
Figure 4-38 shows the plot of filter pressure drop versus SAVY age. Looking at all of the data, there is indication of a negative trend, however, there is considerable scatter and the five containers that have been measured multiple times (colored circles) show no change with age. A slight negative trend for this measurement would not be an issue given that the acceptance criterion does not include a lower limit. To date, all filters have passed acceptance testing.

Figure 4-38. Filter pressure drop versus SAVY age.

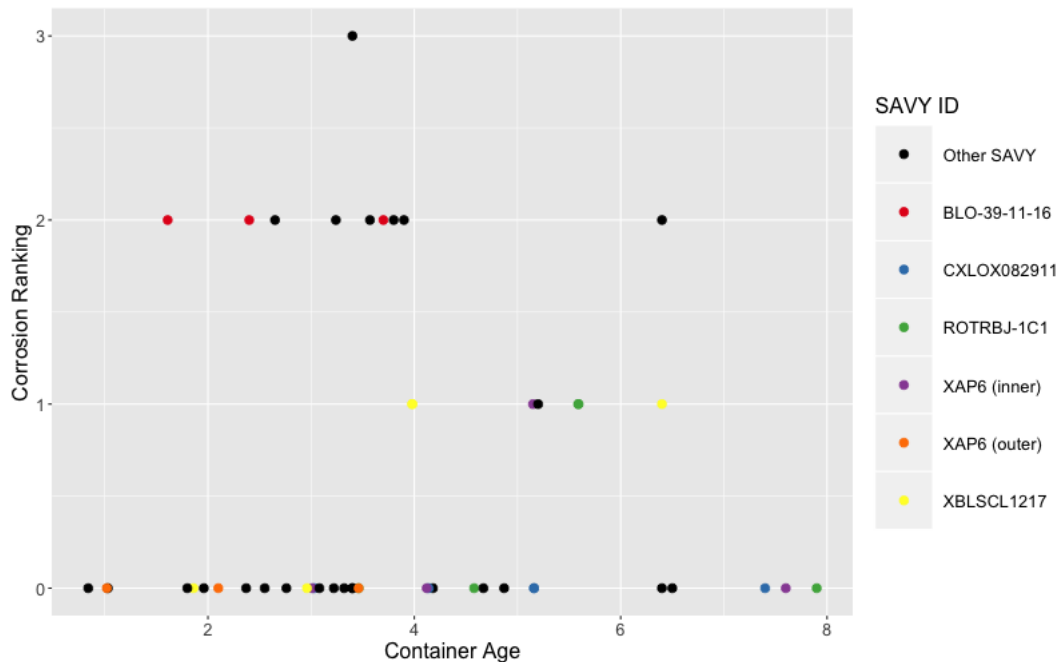
The plot of the corrosion ranking versus age (Figure 4-39) does not show changes with age. Of the containers that were in surveillance multiple years, XBLSCL1217 (yellow dots), XAP6 inner (purple dots) and ROTRBJ-1C1 (green dots) have changed states from the category of no corrosion, but stayed in the same state from 2018 to 2019. However, several of the older containers do not have any corrosion indicating age alone is not a major factor for corrosion. Other factors that may be associated with corrosion include not only age (a), but also wattage (w) and container size. The bag degradation factor (BDF) combines all three of these factors into a single value [9]. BDF is defined as age times wattage divided by the square of the radius of the container ($BDF = a \cdot w / r^2$). Plots of corrosion ranking versus BDF show (Figure 4-40) a slight increasing trend, but it is not statistically significant ($p = 0.10$).

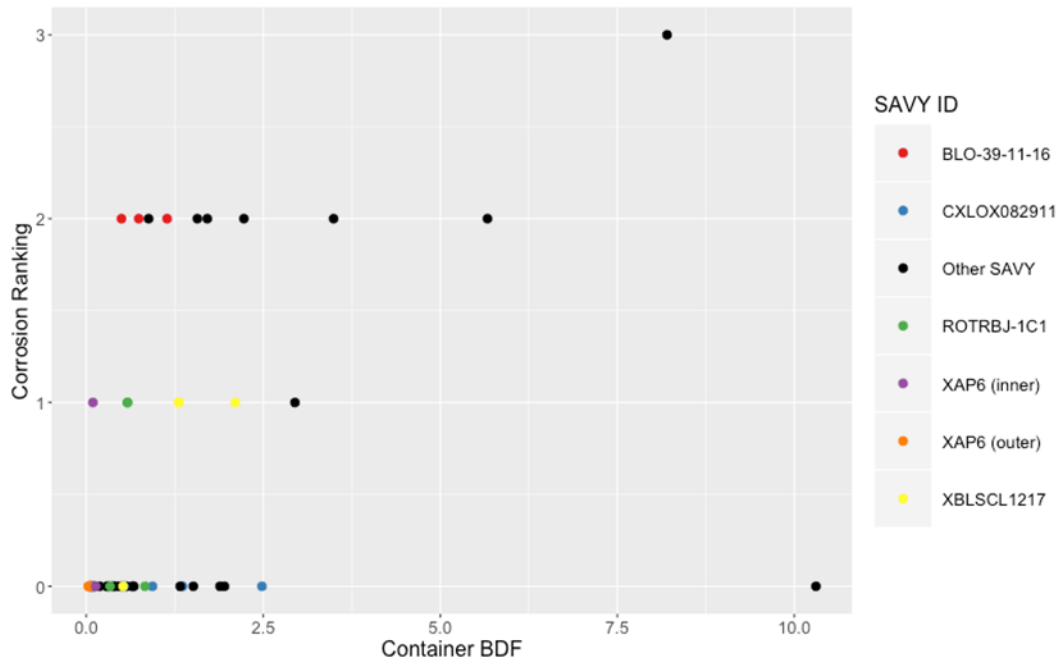
Figure 4-40. SAVY 4000 container corrosion ranking vs. BDF

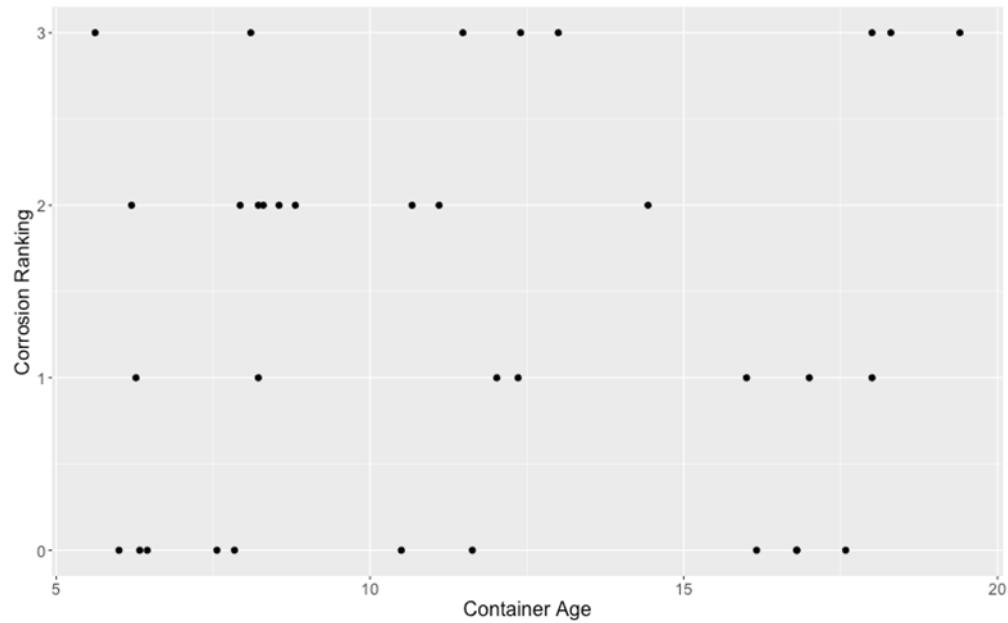
The corrosion ranking scale was applied to all the Hagan containers from 2013 to 2019. A total of 35 containers were inspected based upon visual analysis. Of the 35 containers ranked, 11 were labeled as having no corrosion and 24 had some level of corrosion, with eight Hagan containers labeled in category 3, the highest level of corrosion [8]. Again, factors that are associated with corrosion include age, wattage, and container size. Figure 4-41 shows a plot of the corrosion ranking versus age. The trending analysis shows there are no changes in the corrosion ranking due to age. The plot of corrosion ranking versus BDF, Figure 4-42, shows a slight increasing trend, the greater the BDF the higher the corrosion ranking. However, it is not a statistically significant trend ($p=0.10$).

Figure 4-41. Hagan container age vs. corrosion ranking

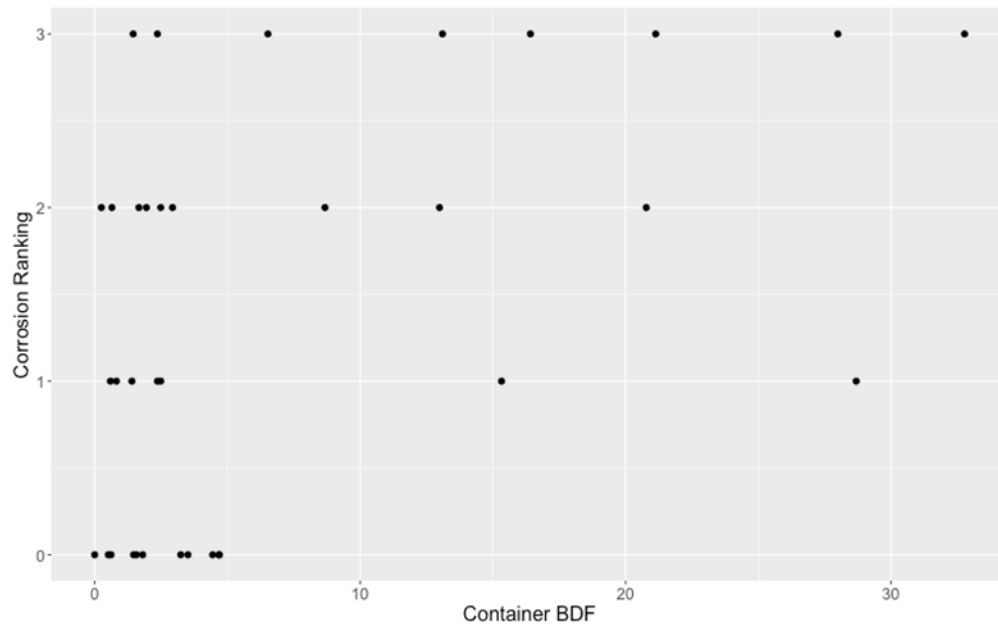
Figure 4-42. Hagan container BDF vs. corrosion ranking
